# Summit Creek Phase 1 Monitoring Plan

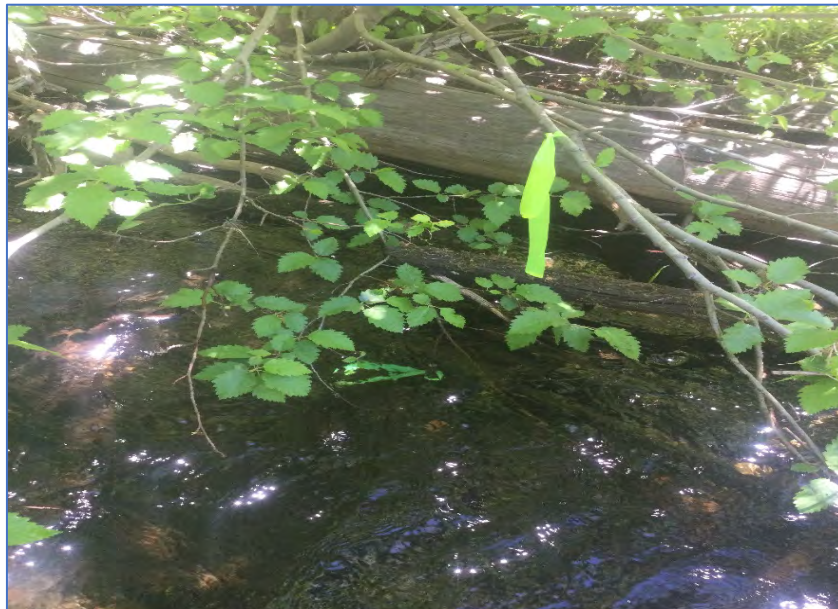
*Figure 8. Photo of temperature monitoring site below Summit Creek PA. Logger is attached to rebar secured within the streambed and flagged for future reference.*

It's likely that the temperature sites within the PA will change in 2022 due to the anticipated ground disturbance, though the sites above and below will remain the same. Pending additional funding more loggers will be purchased for deployment within newly activated channels across the PA valley bottom.

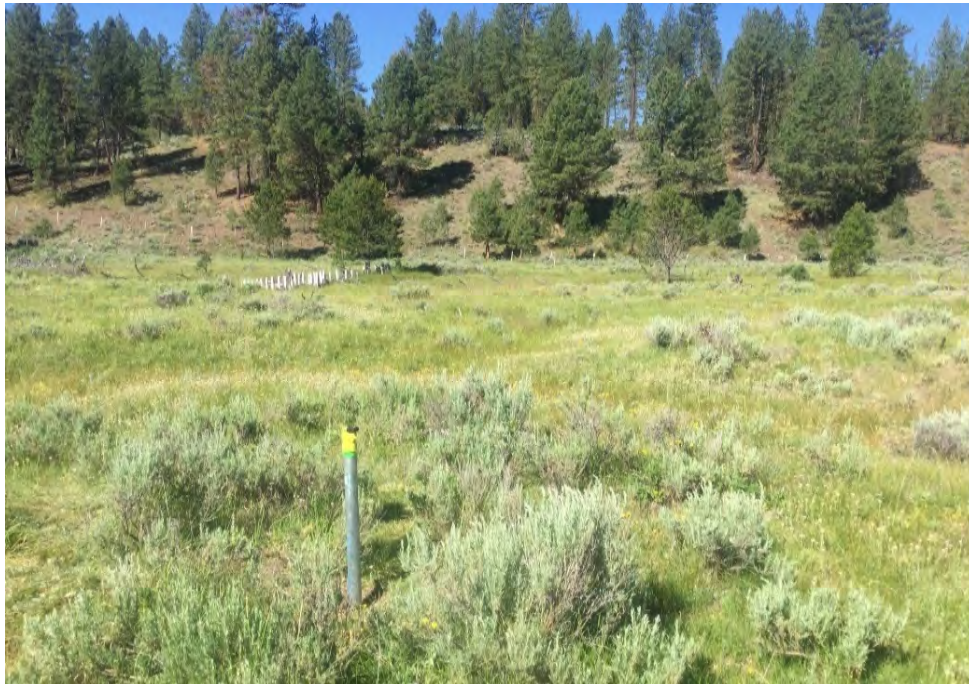
*Figure 11. Photo of Well #3 facing west towards Summit Creek BDA & Well #4*

These level loggers are set to record absolute pressure within each well every 4 hours and are calibrated using a separate U-20 logger recording barometric pressure above the ground surface within the PA. Once corrected for barometric pressure and using a known groundwater surface elevation at the time of deployment/readout, the loggers will be able to provide us with continuous water table elevation readings year-round. This dataset will be used to show changes in groundwater elevation as a result of the floodplain restoration, which is expected to raise the streambed elevation throughout the PA and thus store additional water across the valley bottom. Coupled with transect data showing the relative elevation of various geomorphic features in relation to the wells, we’ll be able to infer groundwater-to-surface water interactions at various points during the year.

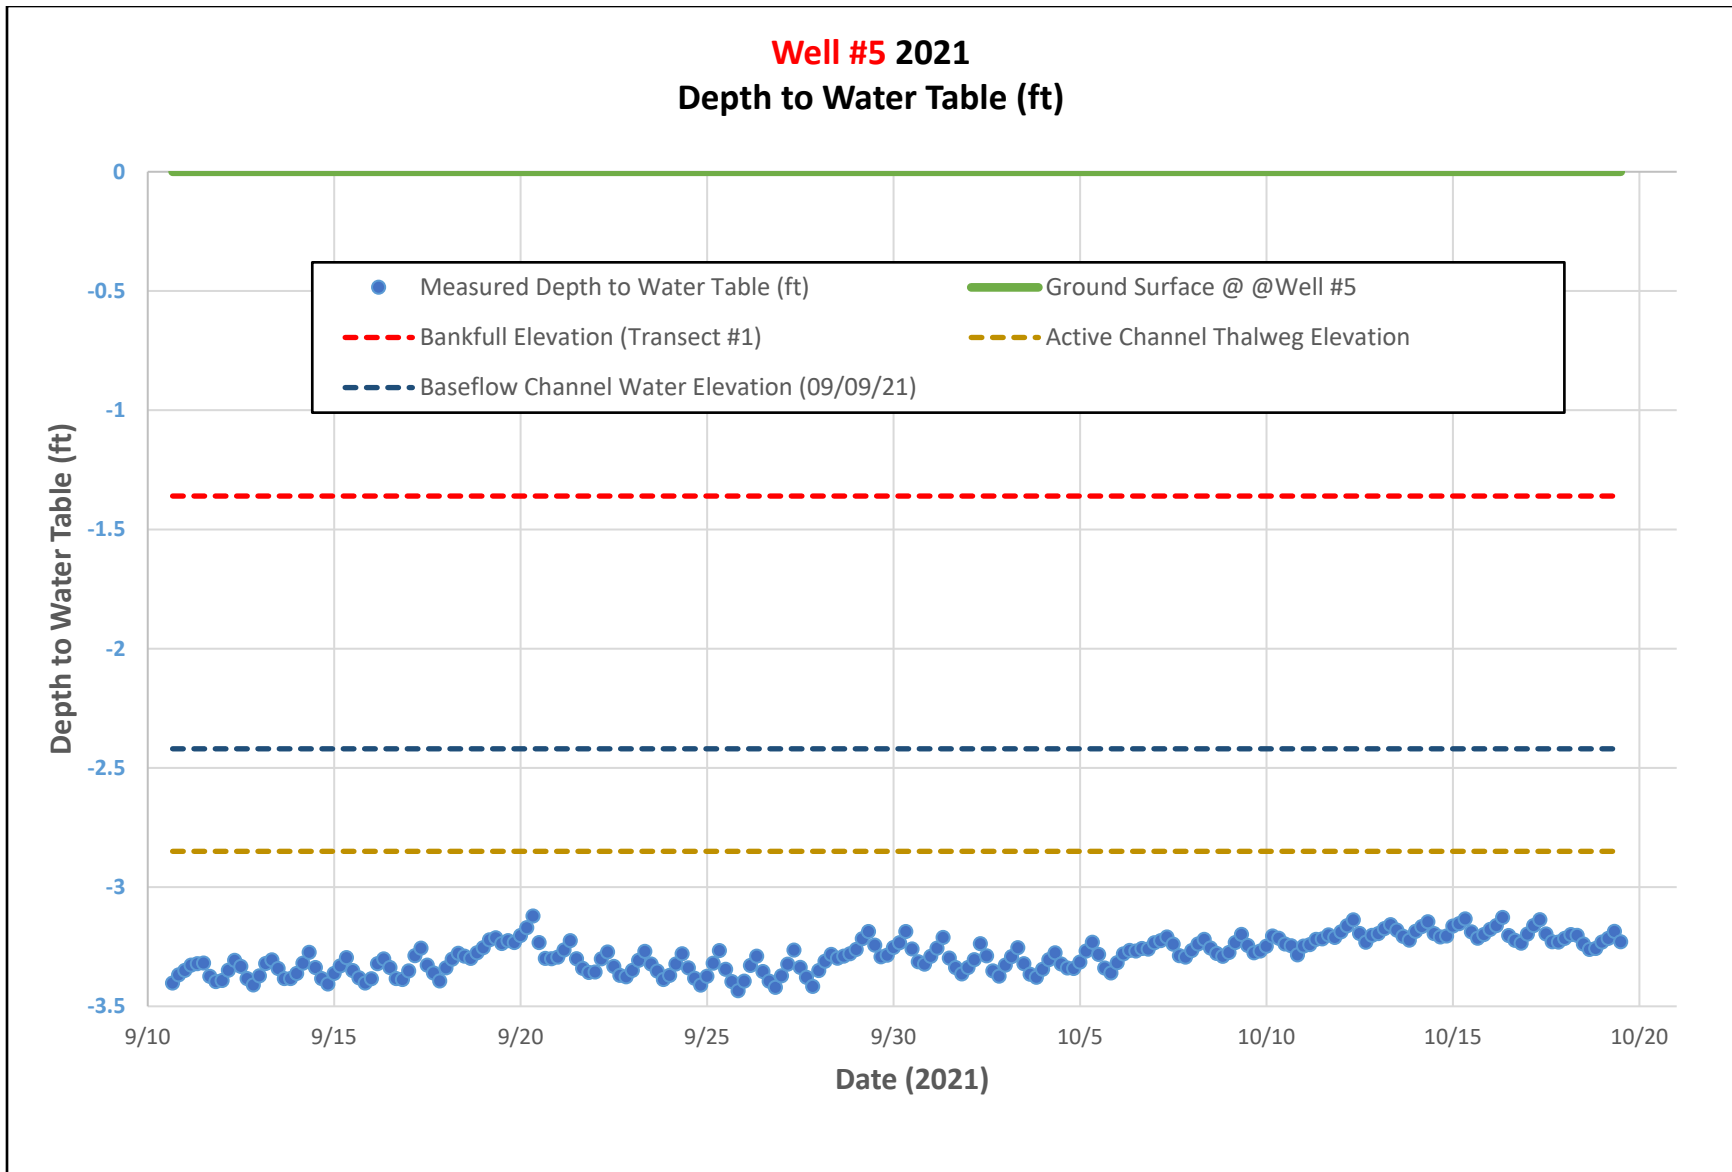
Figure 18. Level logger readings within Well #5 expressed as "depth to water table" & adjacent Summit Creek feature (bankfull, thalweg) elevations taken from Transect #1

Well #5 was not installed until September and thus has a very limited dataset for 2021. It does appear to be in another "losing" reach where the valley bottom water table is lower than the adjacent stream channel. This site will serve as a control dataset with which to compare the other four wells in Phase 1.

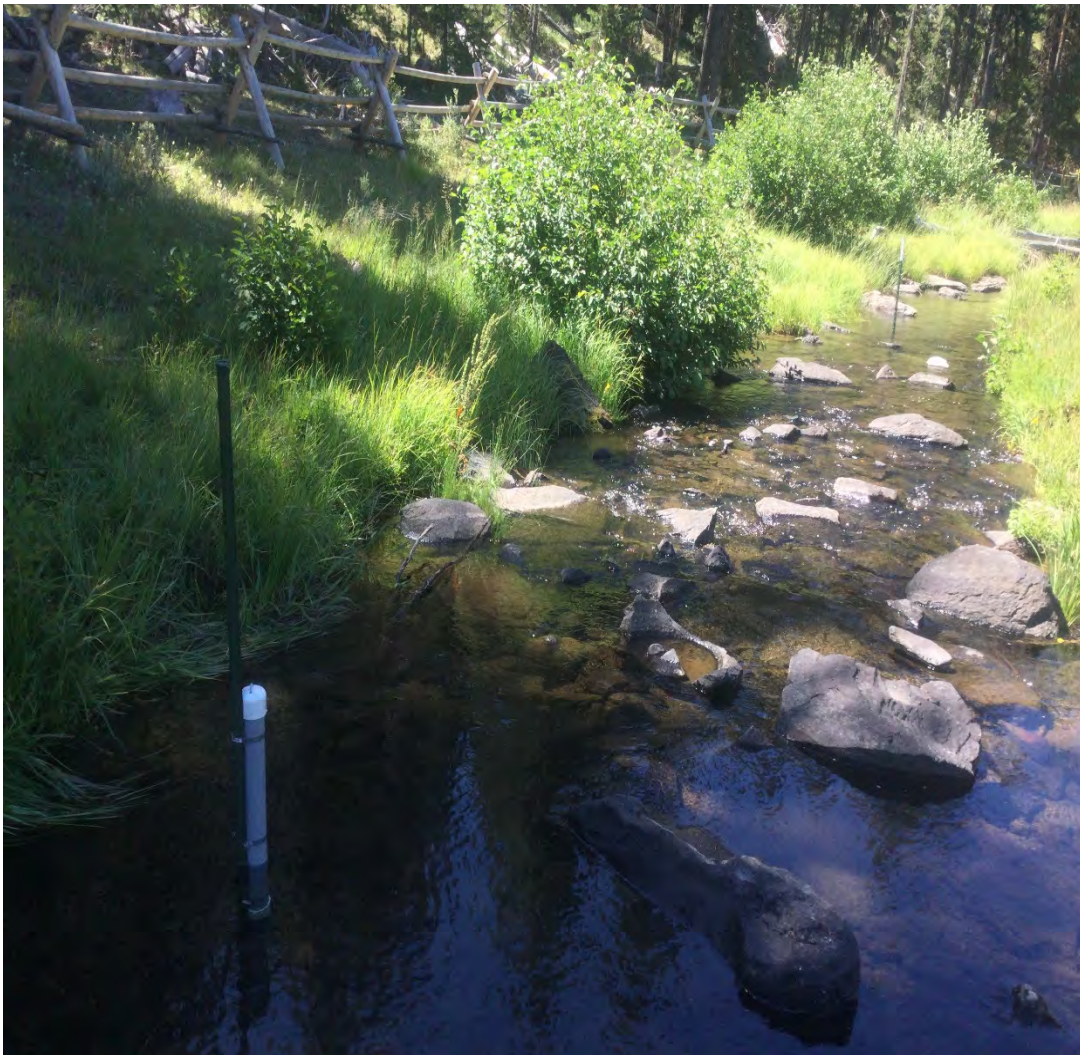
Figure 19. Photo of stream gauge station facing DS towards discharge site marked by T-post

For this site a cross-section was chosen approximately 50' below the stream gauge and a Marsh-McBirney Model 2000 Flo-Mate mechanical current meter was used to measure velocity. Coupled with width & depth measurements, these velocity measurements were used to calculate total discharge for the site. Viewed over the course of several years pre-and-post implementation, streamflow data will provide us with a better understanding of the restoration effects on peak flow events as well as baseflow conditions.

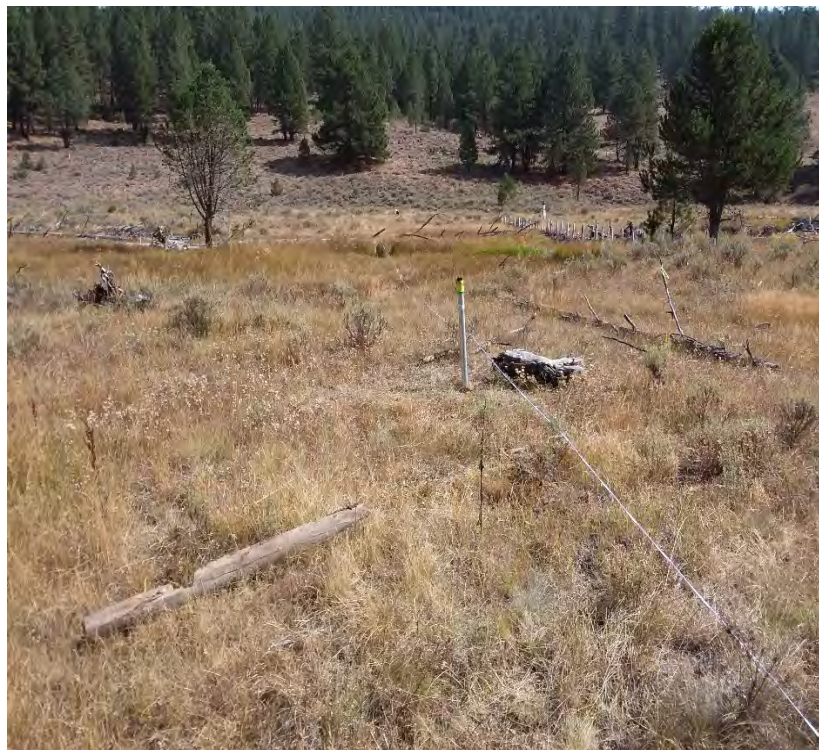
Figure 22. Photo of Transect #2 facing west to east and crossing Well #4 along the Summit Creek Valley Bottom

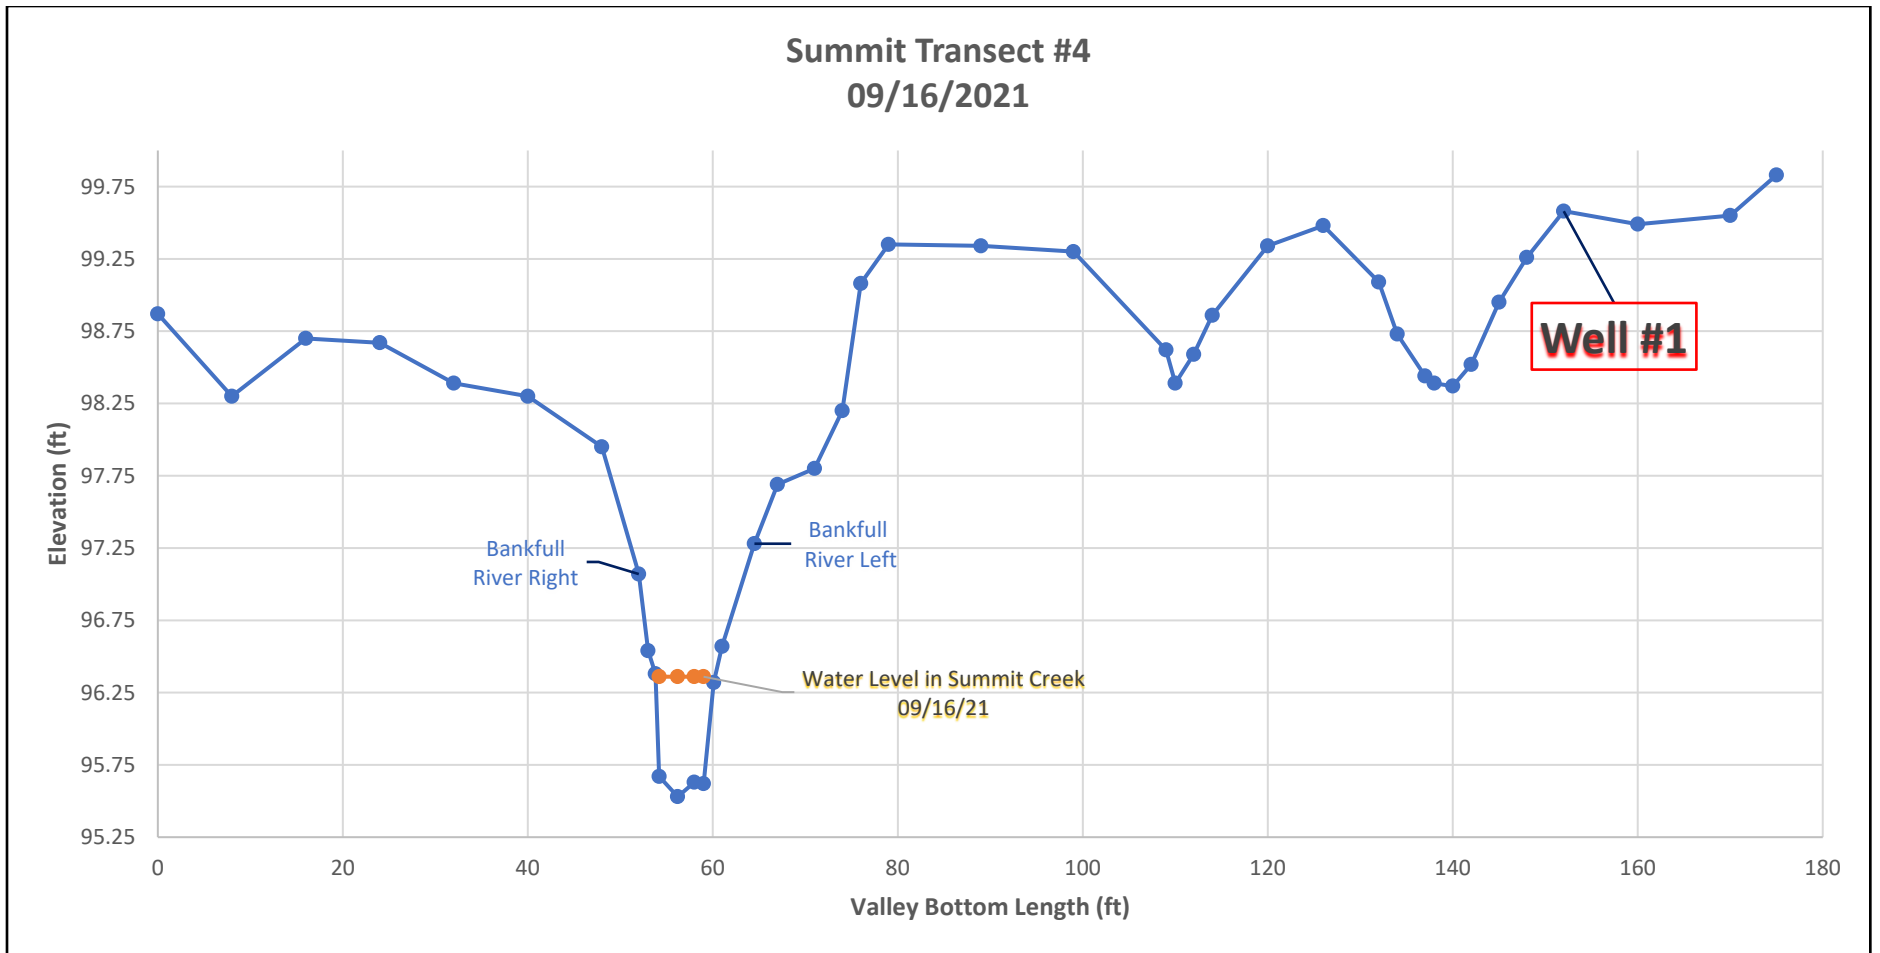
Figure 28. Scatter plot graph of Transect #4, located within Summit Creek PA & intersecting groundwater monitoring Well #1

Relative elevation charts (Figures 25-29) of the five valley bottom transects taken prior to Phase 1 implementation reveal a relatively wide valley bottom (175-363') bordering Summit Creek with numerous relic and seasonally active flowpaths. The active channel, however, is often connected only to a relatively narrow portion of the valley bottom with one or two seasonally active channels at or below bankfull stage. In sections of the valley bottom currently identified as floodplain we see numerous depressions, most likely historic flowpaths or relic channels, which are only currently active during high flow events above bankfull. This data supports our hypotheses that this section of Summit Creek was once an anastomosing network of low-relief, low-energy channels with extensive lateral connectivity from toe slope to toe slope. It also effectively shows the extent to which the current active channel has incised to a depth where it no longer connects via surface flow to its historic channel network on a regular basis.

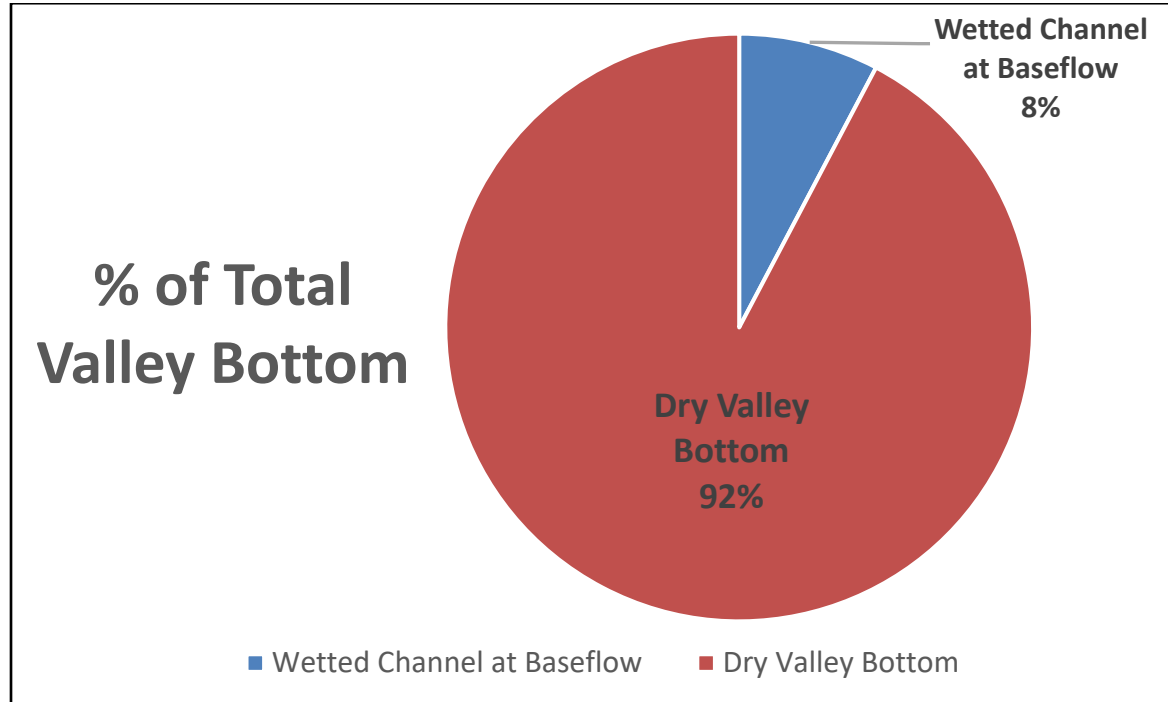
Figure 34. Summary of Valley Bottom area by presence of surface water during baseflow conditions (September 2021)

Valley Bottom Area Type	Acreage	% of Total Valley Bottom	# of GRTS Survey Points
Wetted Channel at Baseflow	0.935	8%	8
Non-wetted Valley Bottom	11.185	92%	92

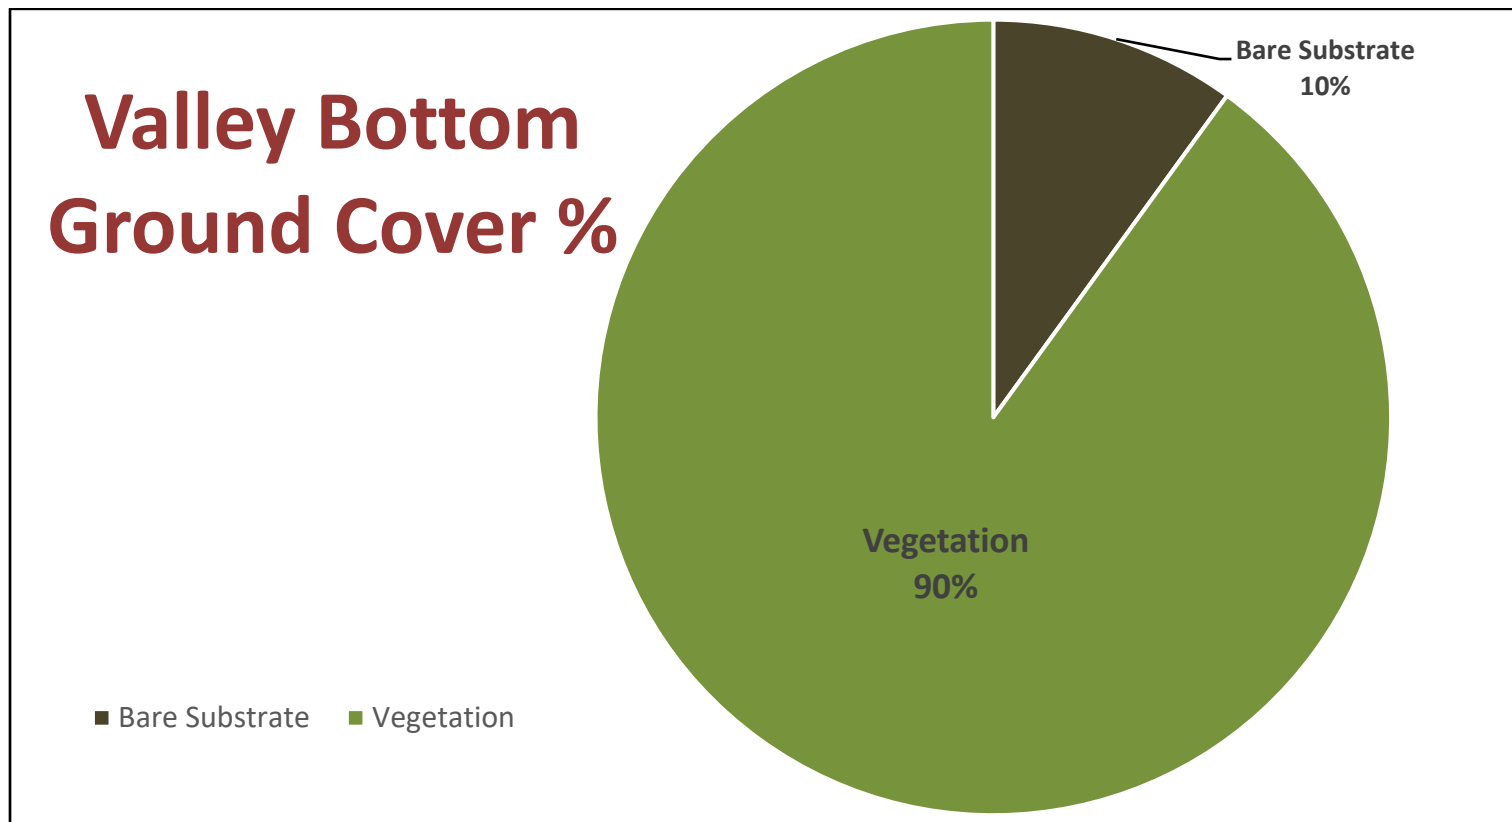
Figure 37. Valley Bottom area by % total ground cover. Note that "bare substrate" includes both sediment within the streambed/active channel area as well as sediment in upland sections of the valley bottom

Valley Bottom Ground Cover	% of Total	Valley Bottom Acreage (12.12 total)
Bare Substrate	10	1.212
Vegetation	90	10.908

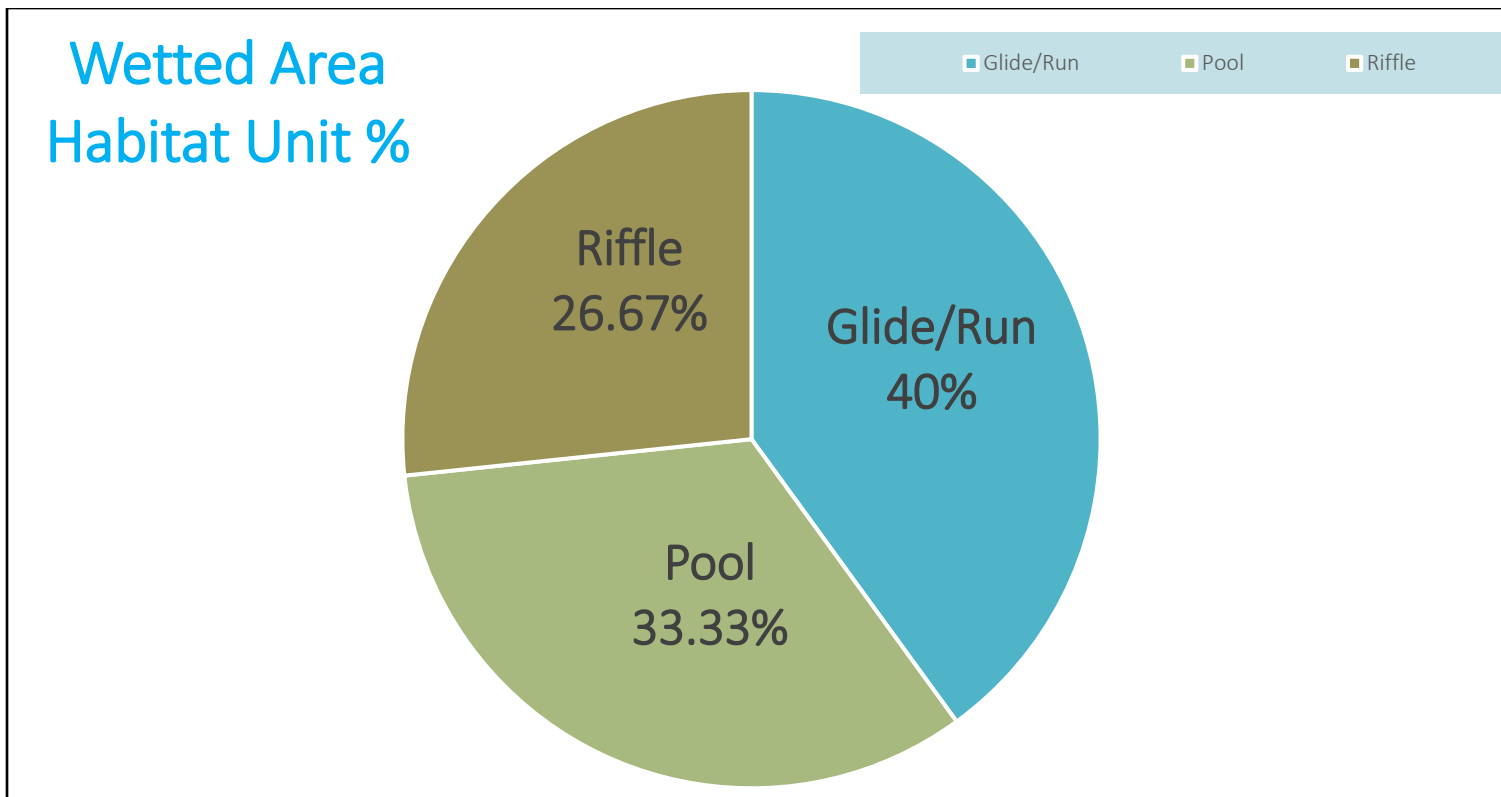
Figure 42. % of total Habitat Unit types within Summit Creek Phase 1 baseflow wetted area (0.935 acres)

Habitat Unit	# of Plots	% of Total
Glide/Run	12	40
Pool	10	33
Riffle	8	27

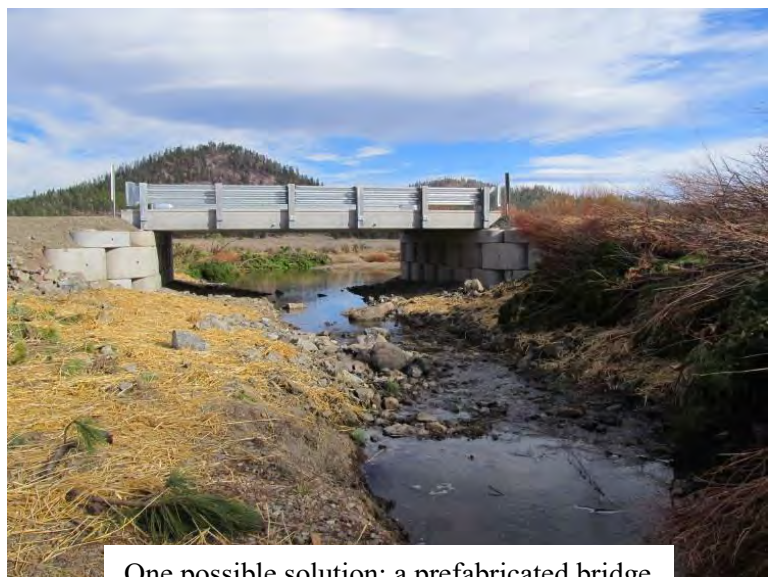
One possible solution: a prefabricated bridge

- On site, we talked about the lower end of the project and how it transitions into the road crossing that will soon be reconstructed. We recommend that you redesign the crossing with an inlet elevation at the historic elevation in your Relative Elevation Model and do Stage 0 through the rest of the valley above the crossing. Stream energies will be very low and even at elevated flows, you will be able to collect flows at the bottom to pass through your new crossing. You will have to bring in fill material to raise the fill height over the culvert or bridge approaches to be able to put in a structure with maximum width, but it will be worth the extra habitat you will generate above it, doing Stage 0 on the rest of the valley.
